## **Appendix 1**

### **Photograph Log**

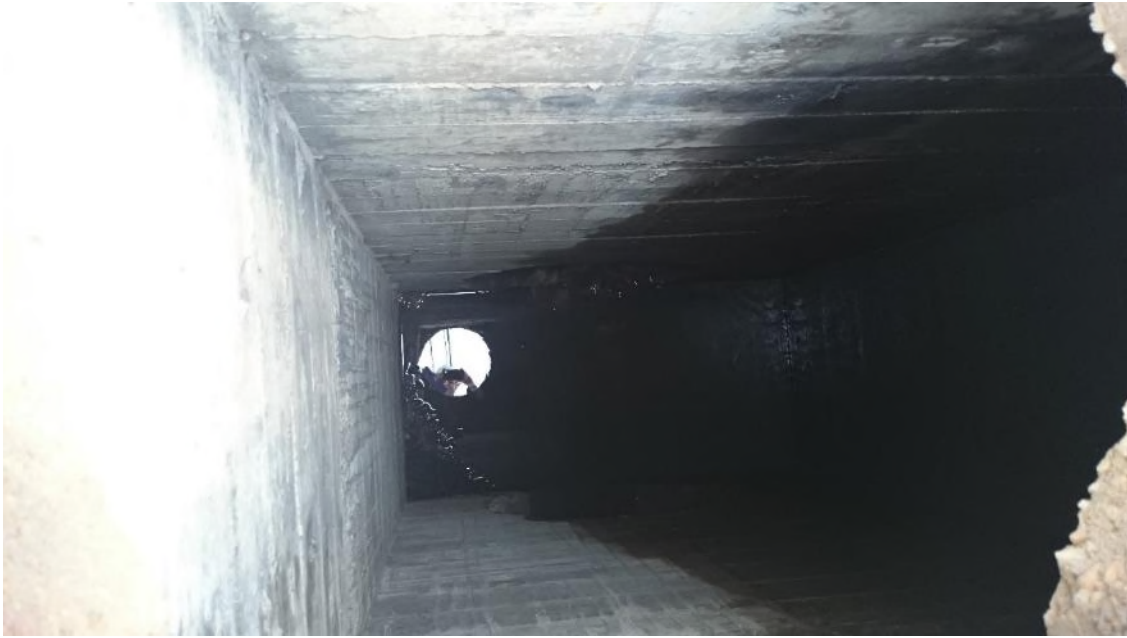
**Photograph 3. Outfall 5-57: Interior of Outfall Manhole.**

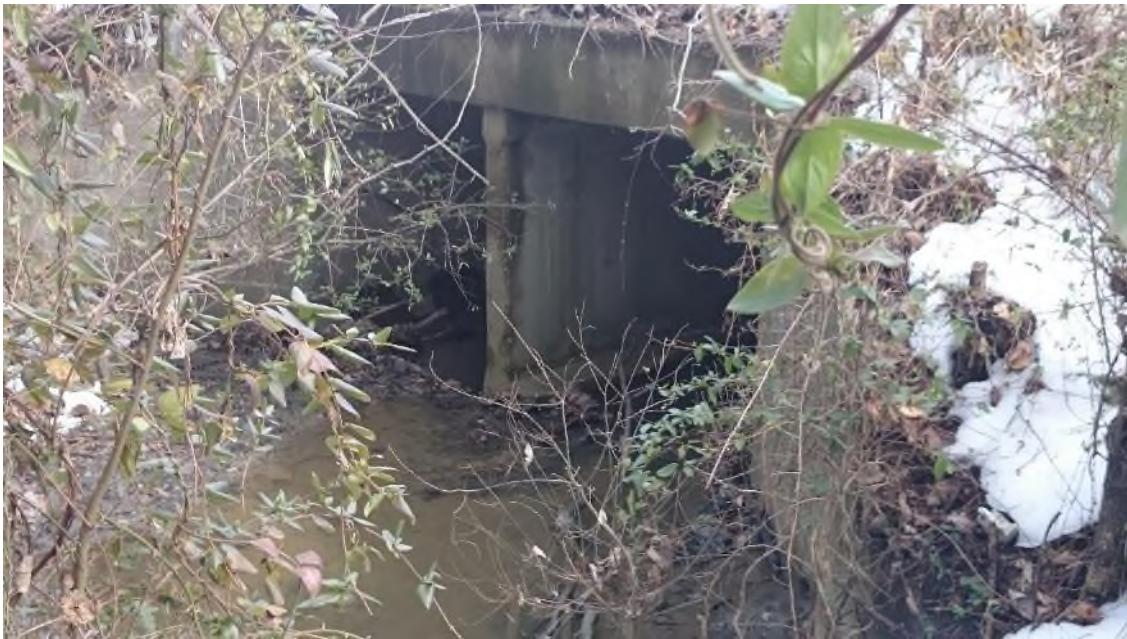
**Photograph 4. Outfall 5-57: Creek that meets Outfall 5-57 pipe located at E. Randolph Road and Winston Churchill Drive.**

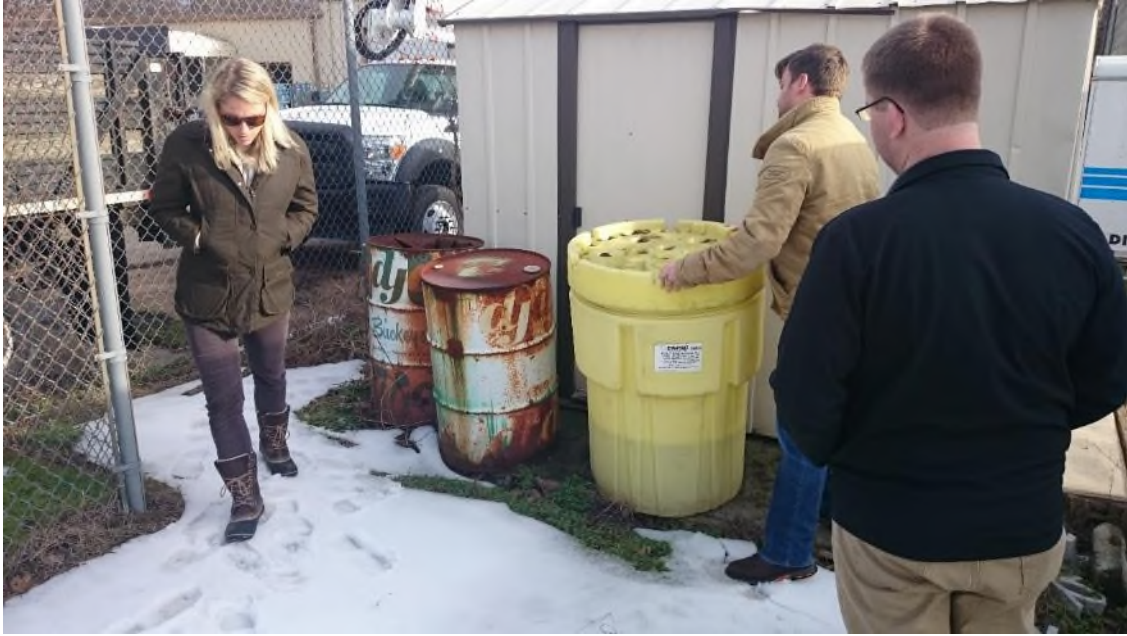
**Photograph 15. Public Works Facility: Two empty drums and an unlabeled yellow barrel containing liquid north of Fire Drills Tower (Building B- Facility Map).**

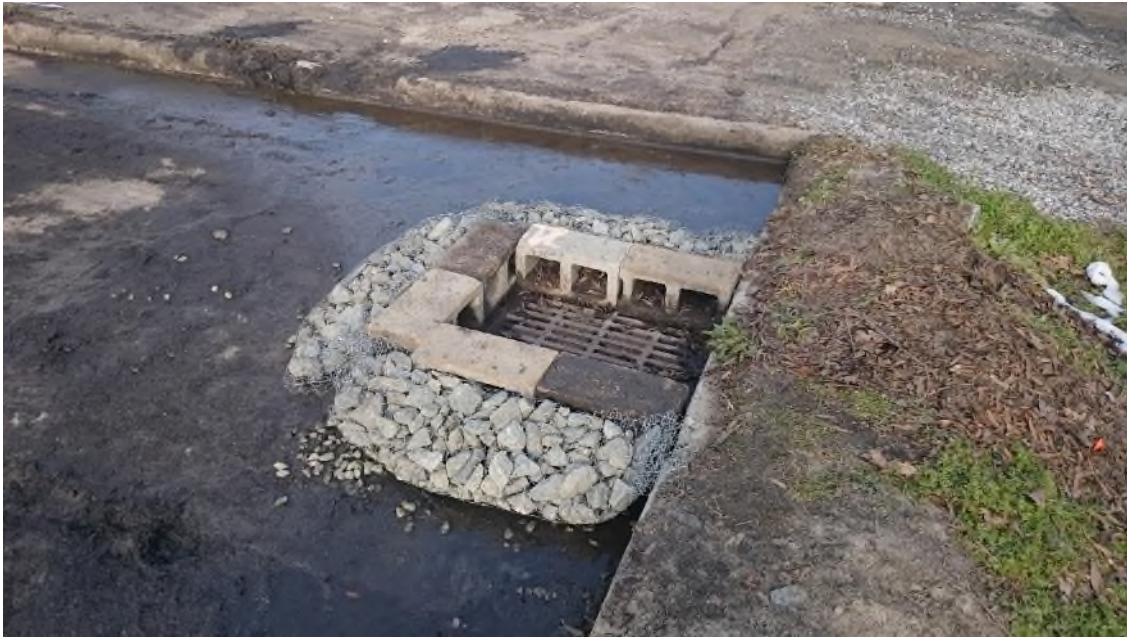
**Photograph 16. Public Works Facility: Catch basin with inlet protection located between Vehicle Maintenance Chemical Storage Area 2 and Vehicle/Equipment Maintenance Chemical Storage Area 5 (Facility Map).**

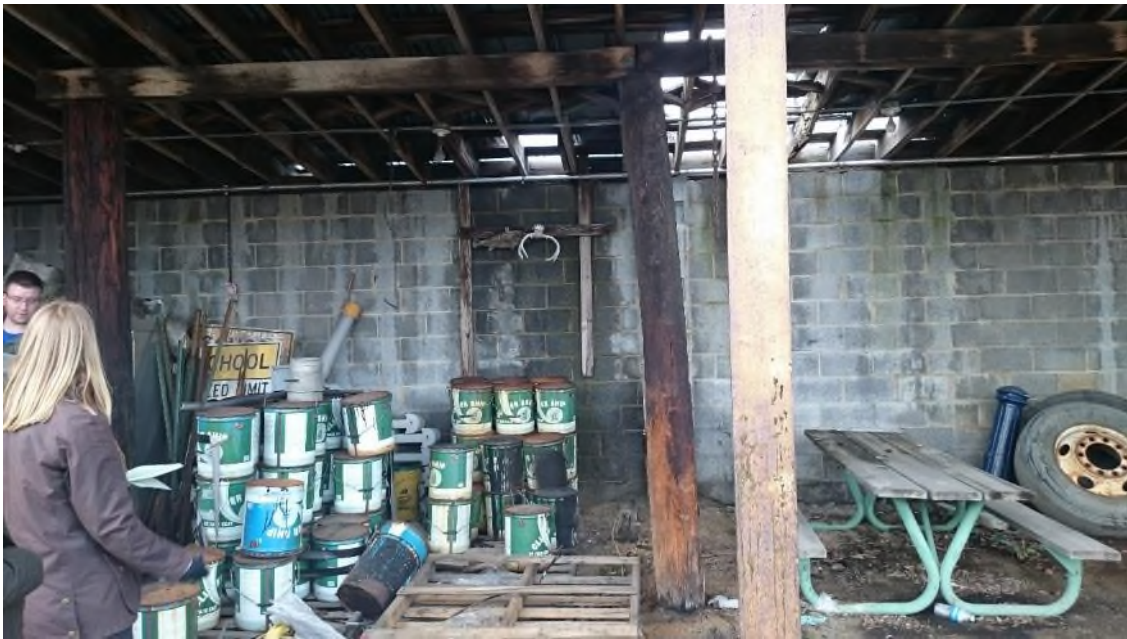
**Photograph 18. Public Works Facility: Equipment and Materials Storage Building (Building F - Facility Map) with compromised roof.**

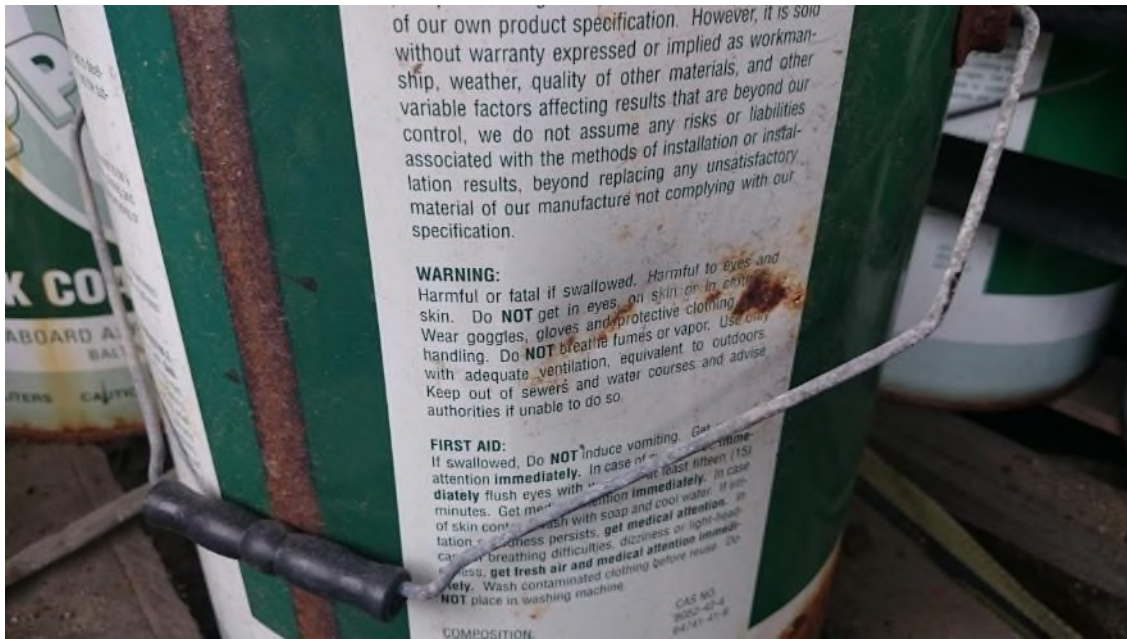
**Photograph 19. Public Works Facility: Partial label on the container stored in the Equipment and Materials Storage Building depicted in Photograph 18.**

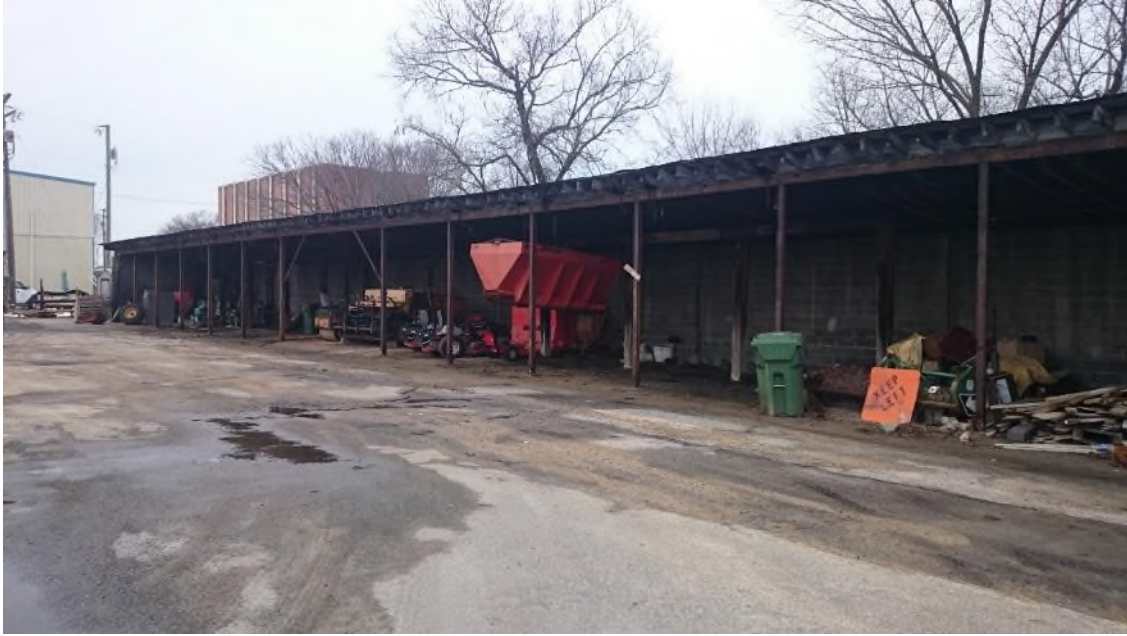
**Photograph 25. Public Works Facility: Entire view of Equipment and Materials Storage Building (Building F - Facility Map).**

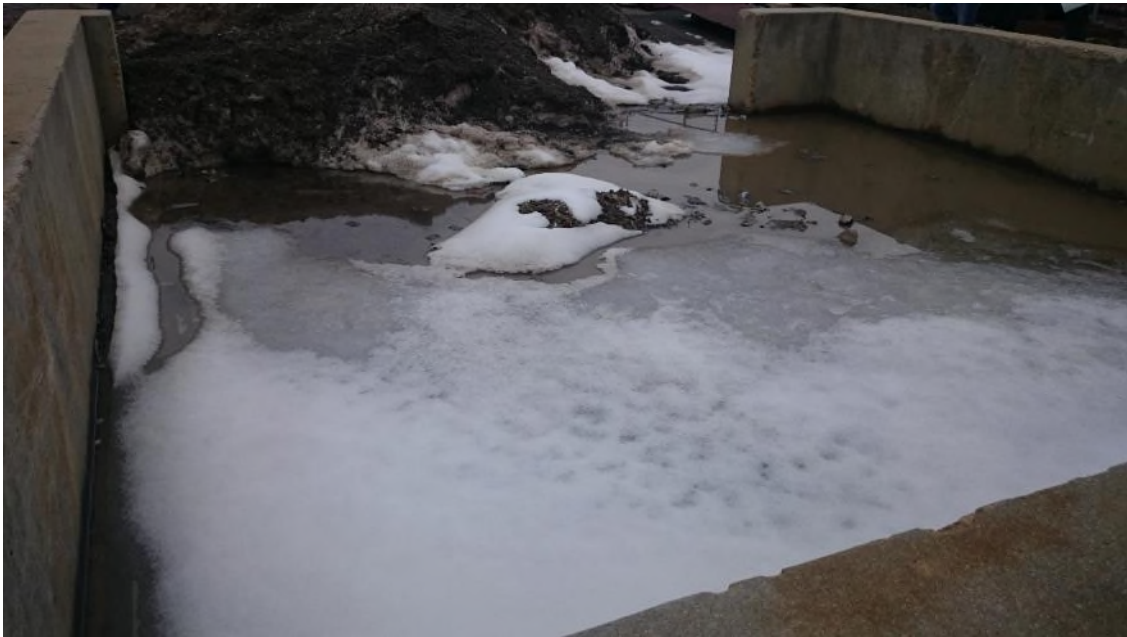
**Photograph 28. Public Works Facility: Standing water near low point at the Vehicle Washing Area 11 (Facility Map).**

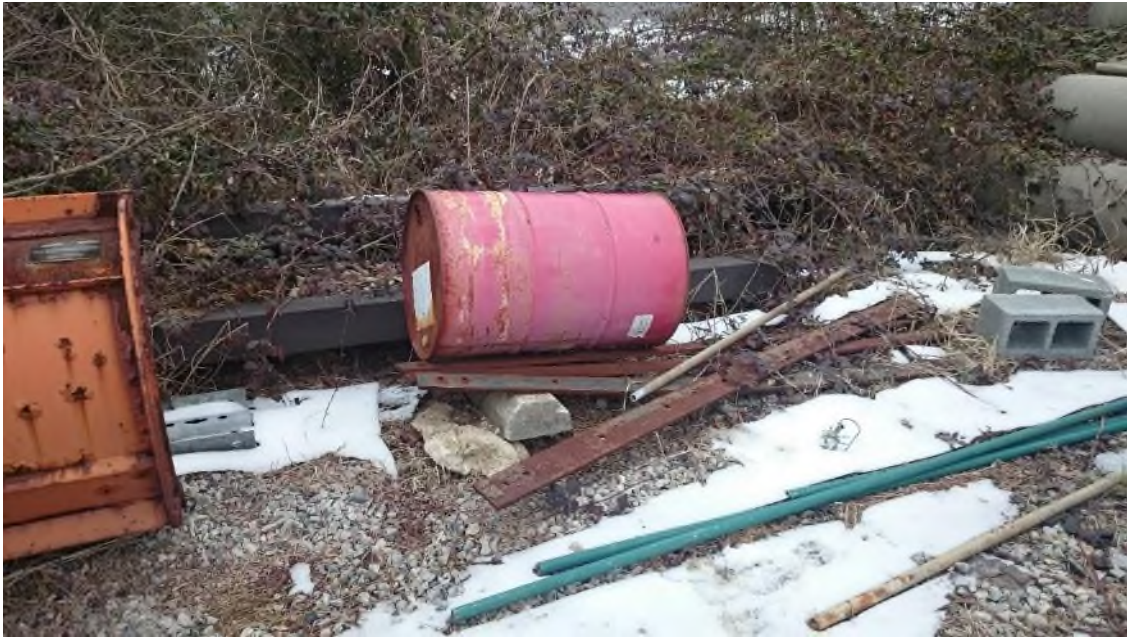
**Photograph 34. Public Works Facility: Empty barrel and rusted metal debris located near Trash Storage Area 14 (Facility Map).**

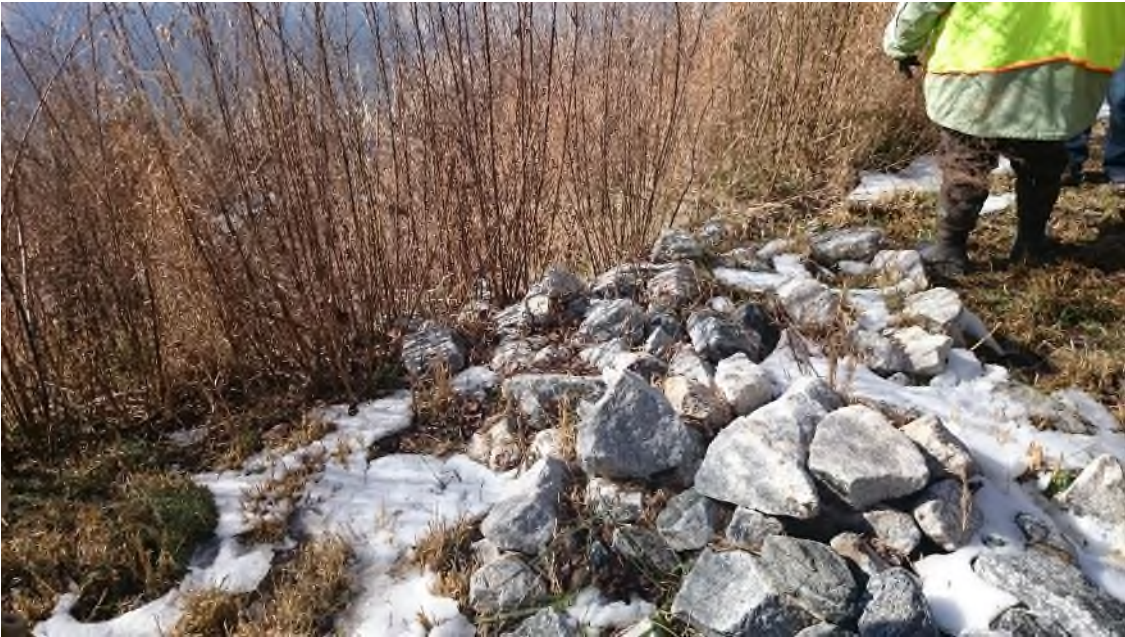
**Photograph 58. Hopewell High School Stormwater Management Facility: Alternate view of wetland erosion stabilized with riprap.**

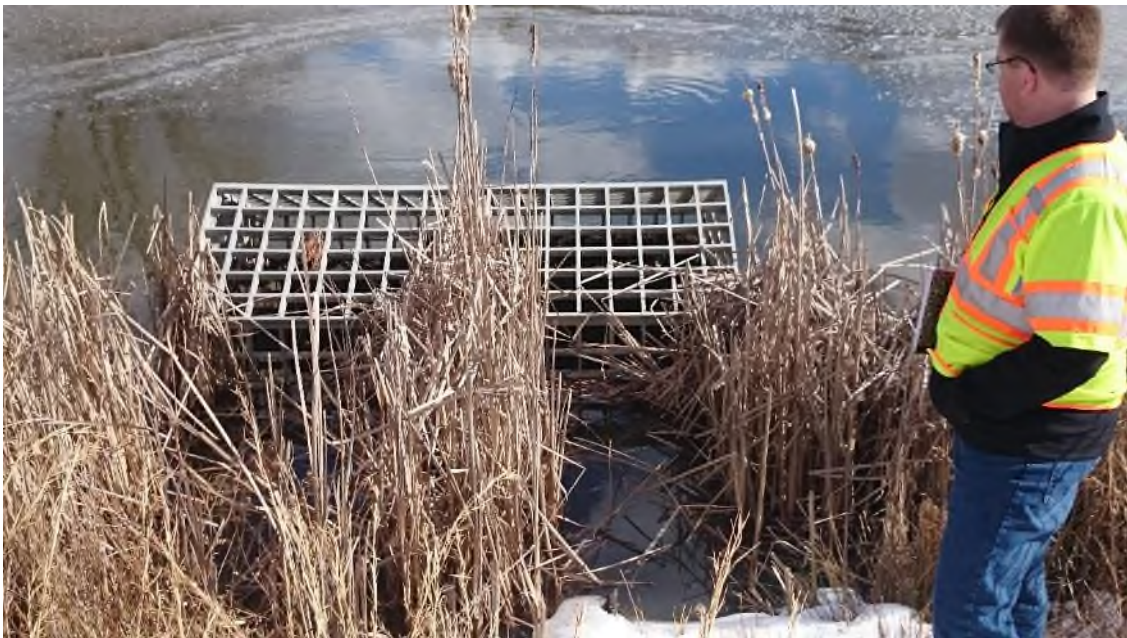
**Photograph 62. Hopewell High School Stormwater Management Facility: Pond riser structure.**

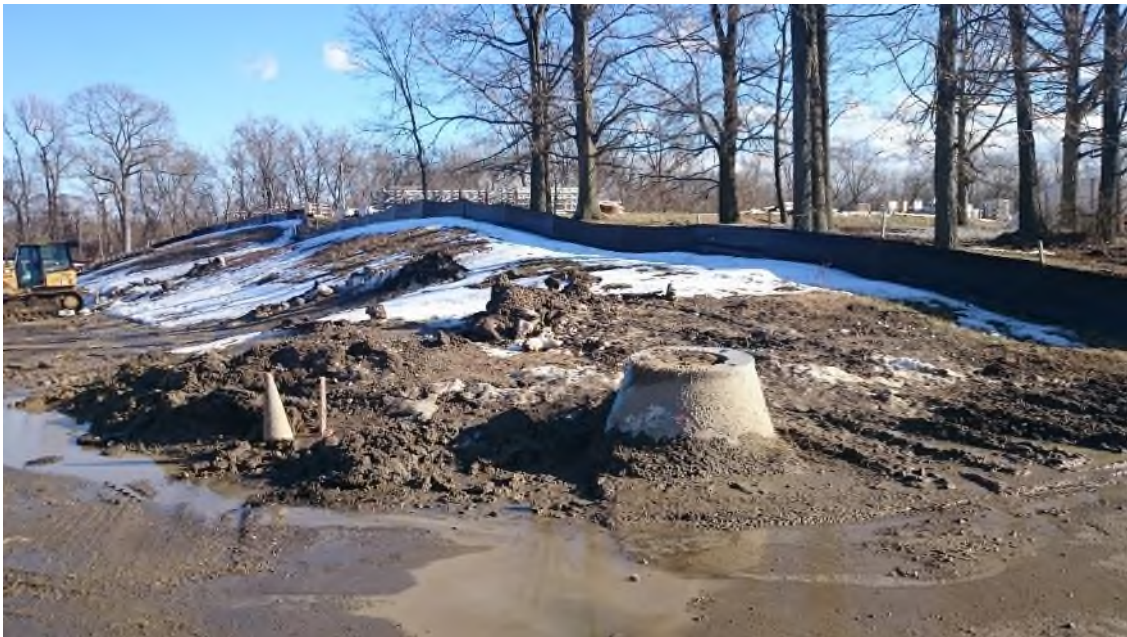
**Photograph 76. Hopewell Regional Wastewater Treatment Plant Construction Site:  
Alternate view of disturbed embankment.**

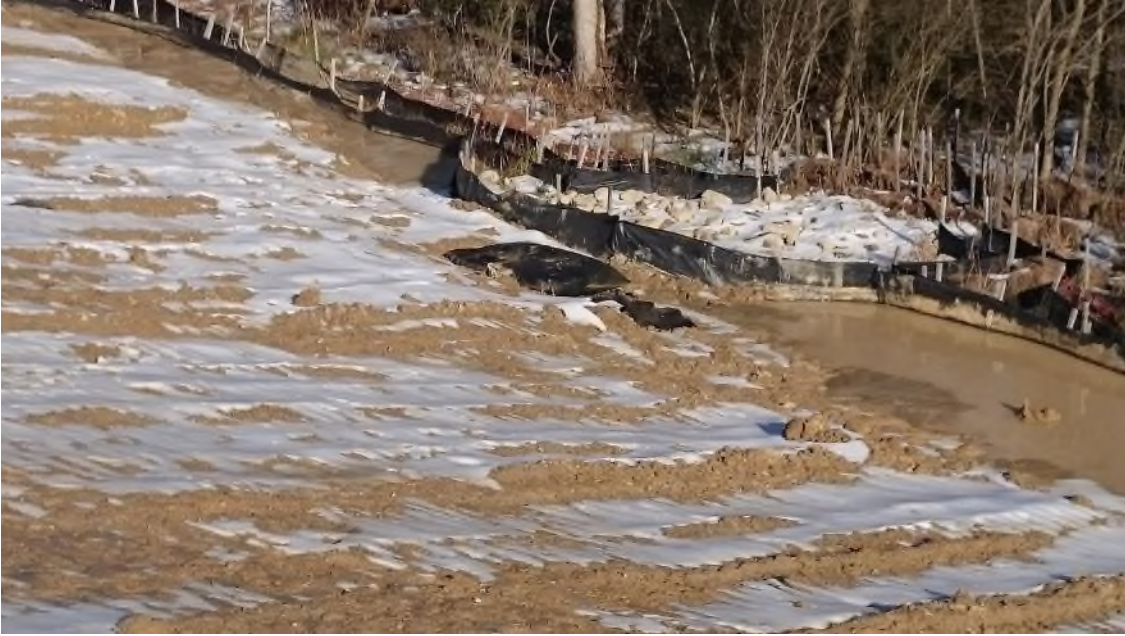
**Photograph 93. Hopewell Regional Wastewater Treatment Plant Construction Site: On the far side of the embankment from Photographs 83-88, showing a dewatering bag actively leaking.**

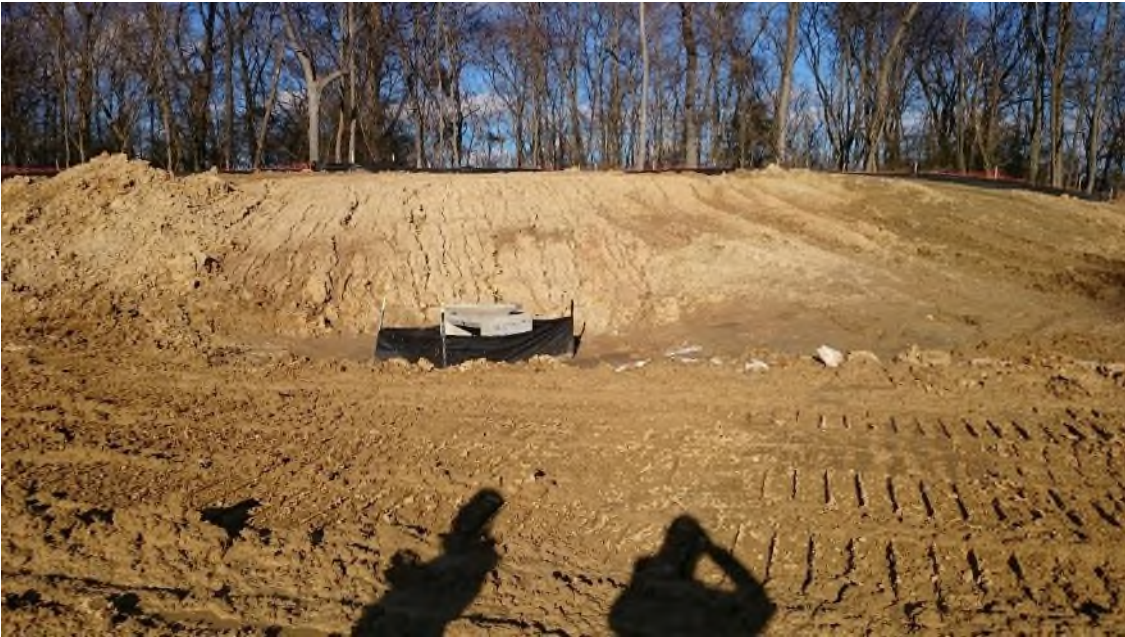
**Photograph 94. Hopewell Regional Wastewater Treatment Plant Construction Site: Construction embankment with rilling.**

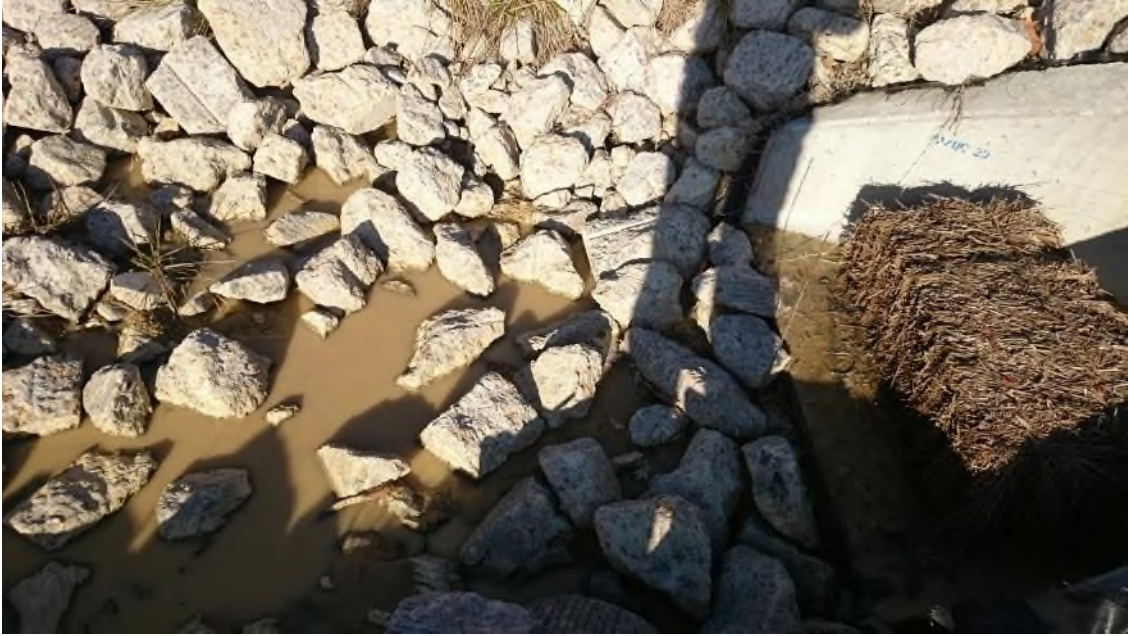
**Photograph 103. Hopewell Regional Wastewater Treatment Plant Construction Site:  
Closer view of silty water draining from outfall of sediment basin 1.**

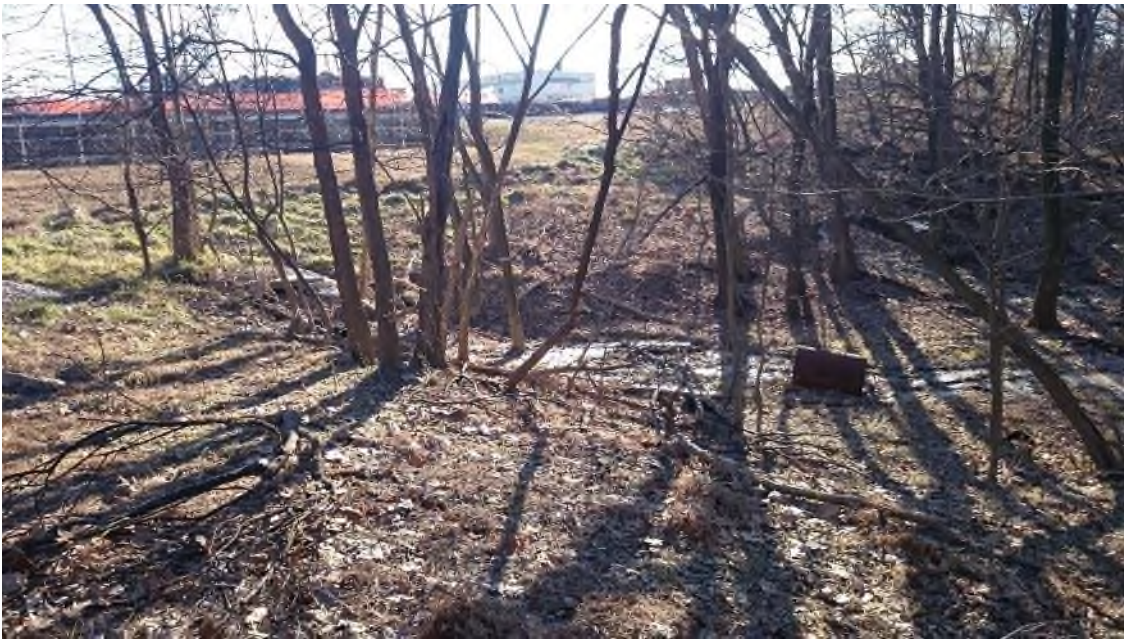
**Photograph 107. Hopewell Regional Wastewater Treatment Plant Construction Site: Close up view of silty water flowing downhill of outfall pictured in Photographs 101-104.**
